# UNDERWATER BRIDGE INSPECTION REPORT

STRUCTURE NO. 7274

LE SUEUR RIVER

MINNESOTA DEPARTMENT OF TRANSPORTATION  
UNDERWATER BRIDGE INSPECTION

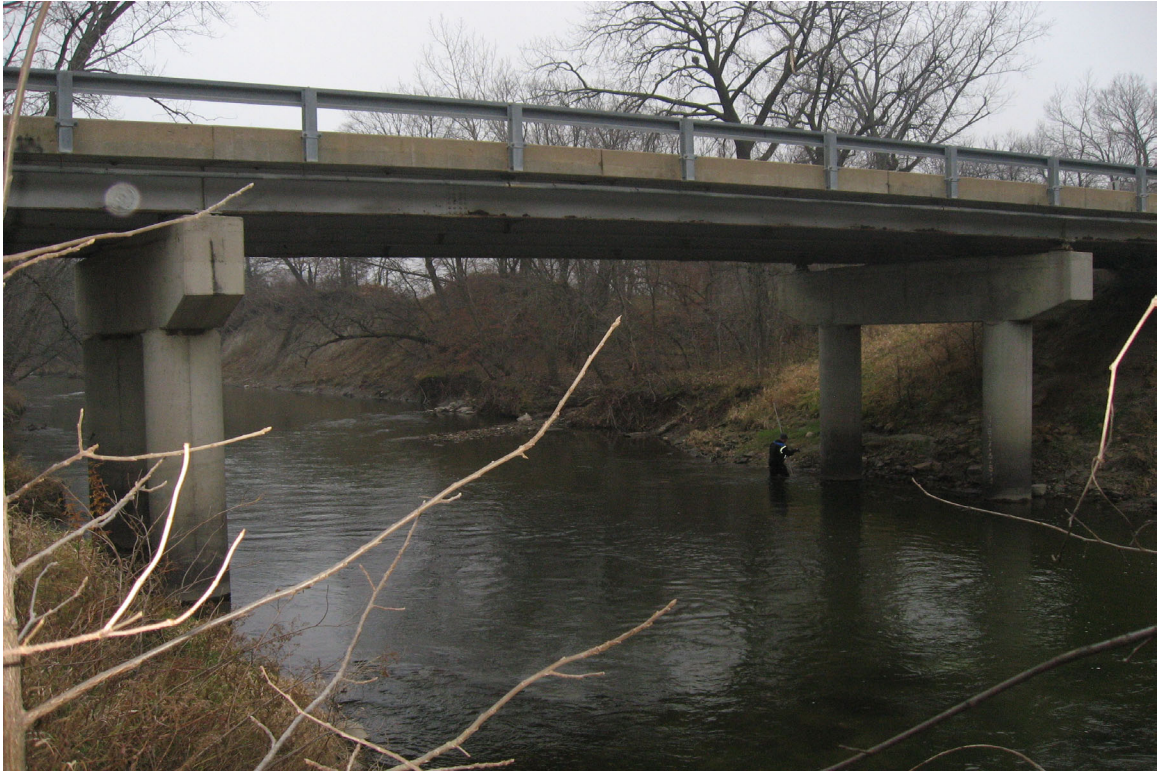
Photograph 1. Overall View of Bridge, Looking Southeast.

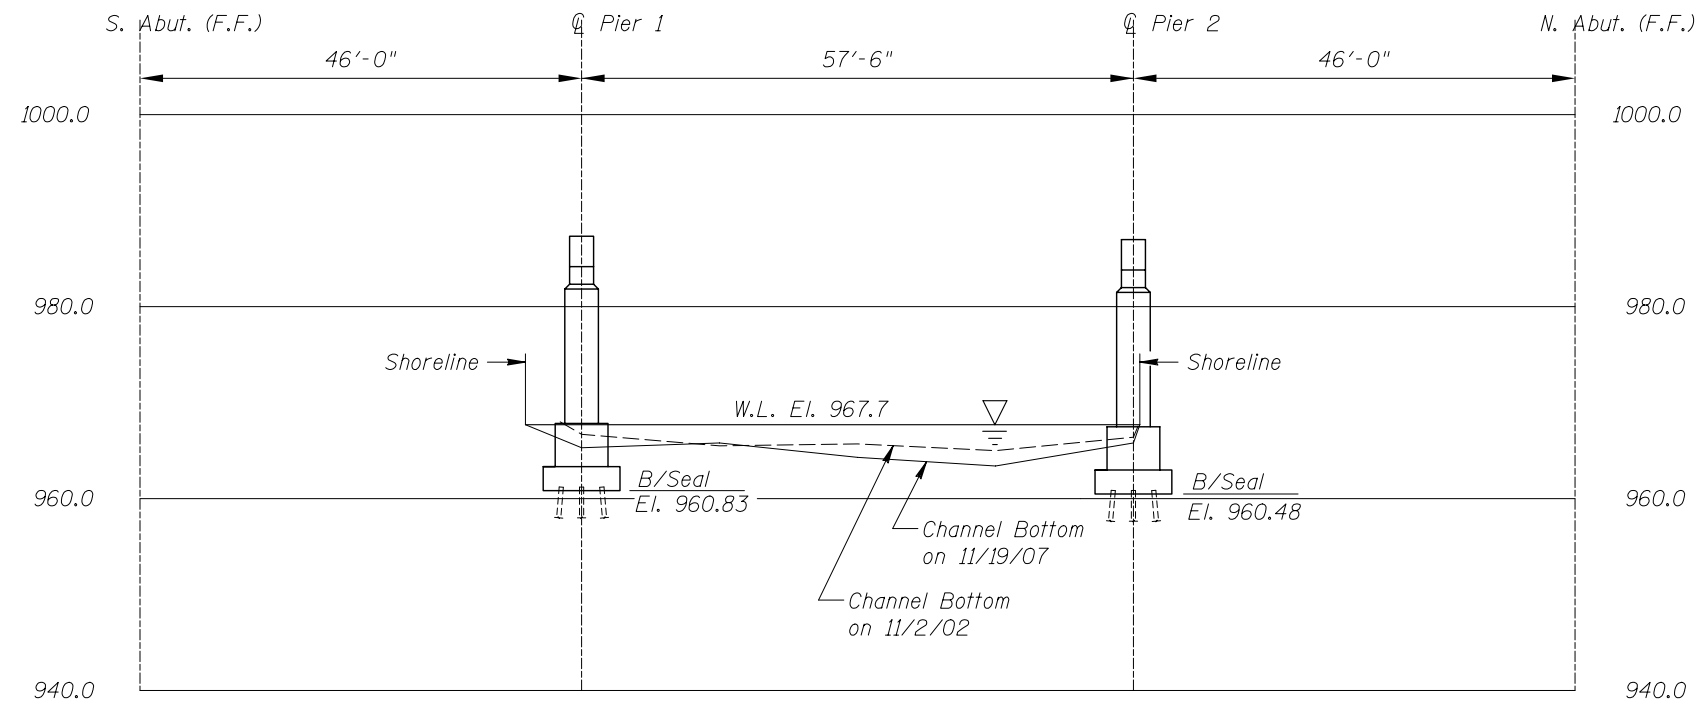
UPSTREAM FASCIA PROFILE

REMARKS: Overall, the concrete piers were in good to satisfactory condition. The top of the diaphragm at both piers was exposed with up to 2.2 feet of vertical face exposure at the upstream ends. The top of the exposed diaphragm at Pier 2 exhibited heavy section loss and exposed aggregate and reinforcing steel was present along the entire exposed portion. The channel bottom appeared stable with no evidence of significant scour.

Ideally, the deteriorated concrete of the diaphragm at Pier 2 should be repaired by removing the unsound concrete and reforming with a concrete mix designed to promote high durability and low permeability. Continue to monitor the diaphragm deformation until repairs are accomplished.
